United States Department of the Interior
National Park Service
National Register of Historic Places Registration Form

Historic Name: Garland Downtown Historic District (Boundary Increase for Alston House)
Other name/site number: NA
Name of related multiple property listing: NA

Street & number: 212 N. 7th Street
City or town: Garland State: Texas County: Dallas
Not for publication: [] Vicinity: []

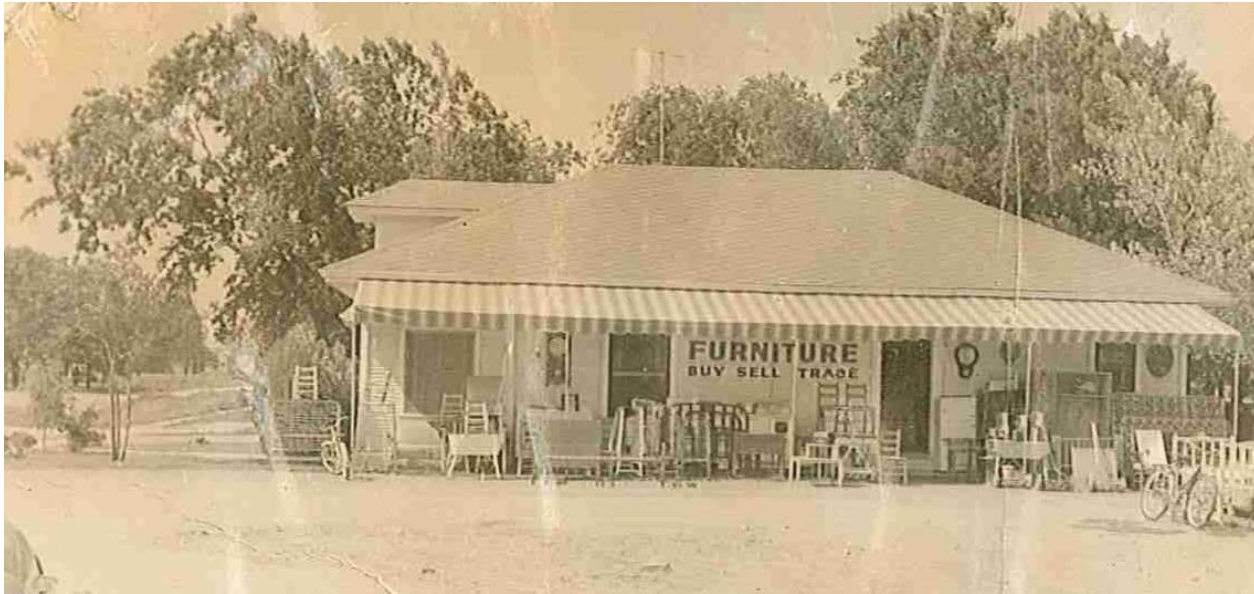
Figure 1: View of south elevation, looking north. Note canvas awning and furniture sign, c 1953. Courtesy of the Alston family.

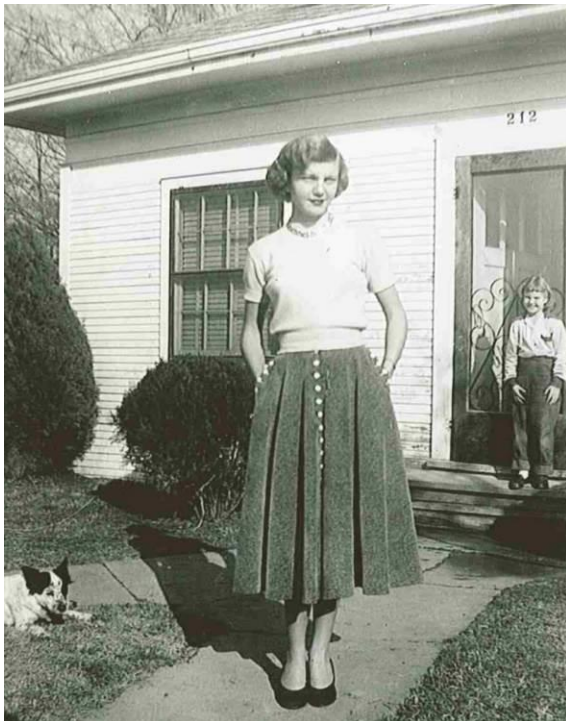
Figure 2: View of front elevation, note 6-over-6 window on enclosed porch, c 1953. Courtesy of the Alston family.

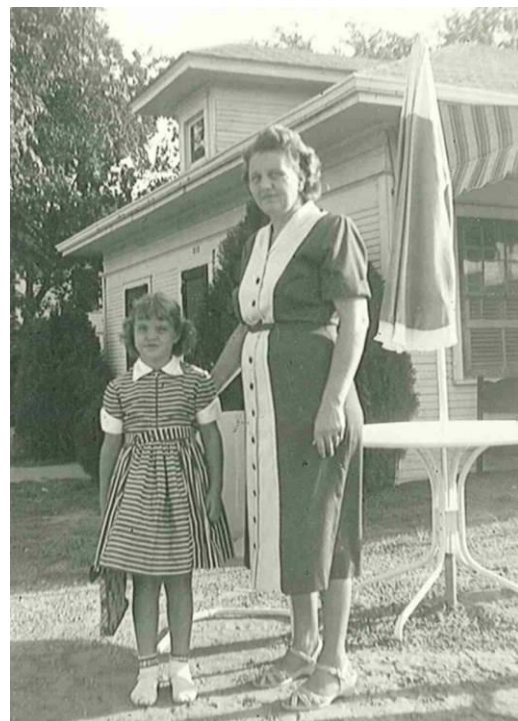
Figure 3: View of southeast corner, note canvas awning, c. 1953. Courtesy of the Alston family.

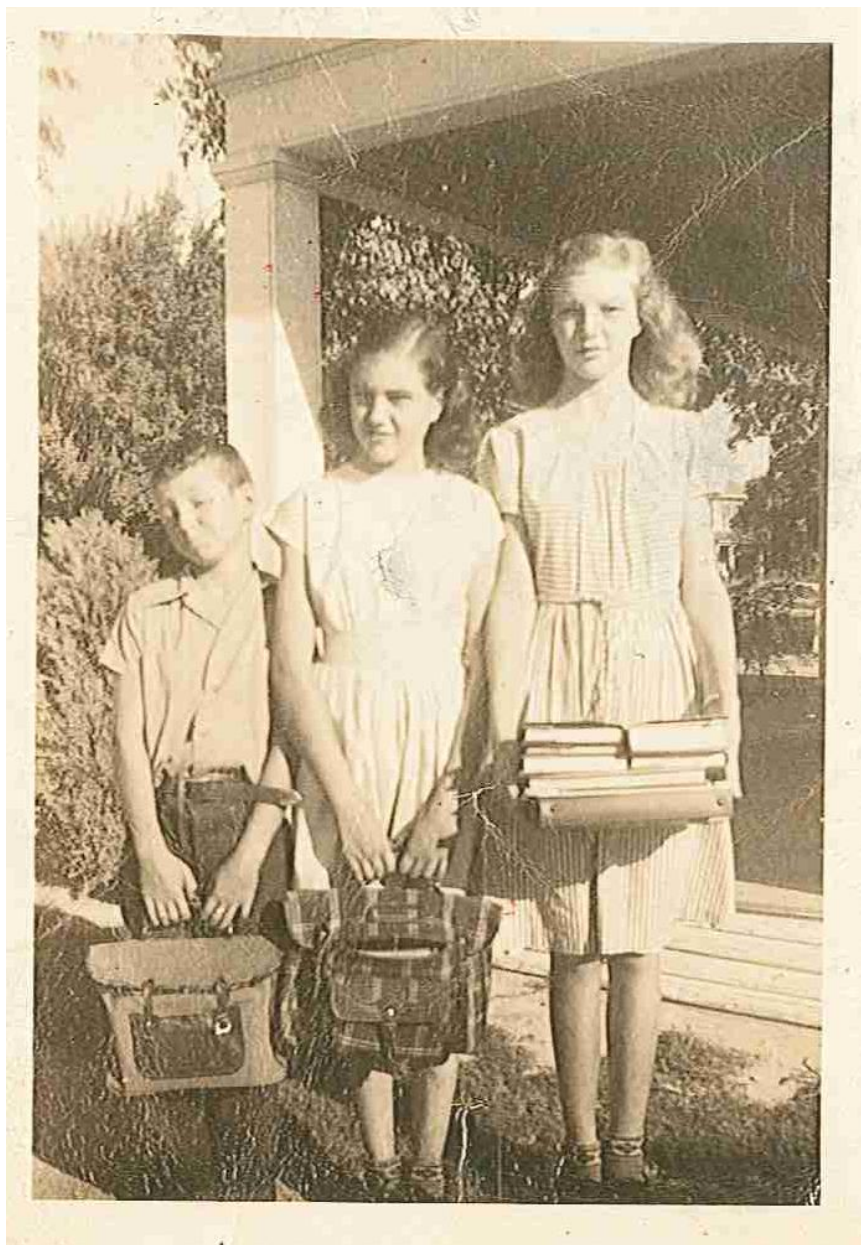
Figure 4: This photograph might show the front porch before it was enclosed but could not be verified because of a lack of context. In the photograph are three of the Alston children. The family had lived in Garland for several years by the time this photograph was taken for possibly the first day of school. Similar shrubs can be found in these locations in later photographs of the enclosed porch. The photograph might be of the southwest corner of the porch looking northwest. Courtesy of the Alston family.

Photo 13: Note the trim in the cornice is similar to trim in Figure - 4. This is one of the few clues that Figure - 4 might be the original porch. Camera facing east.

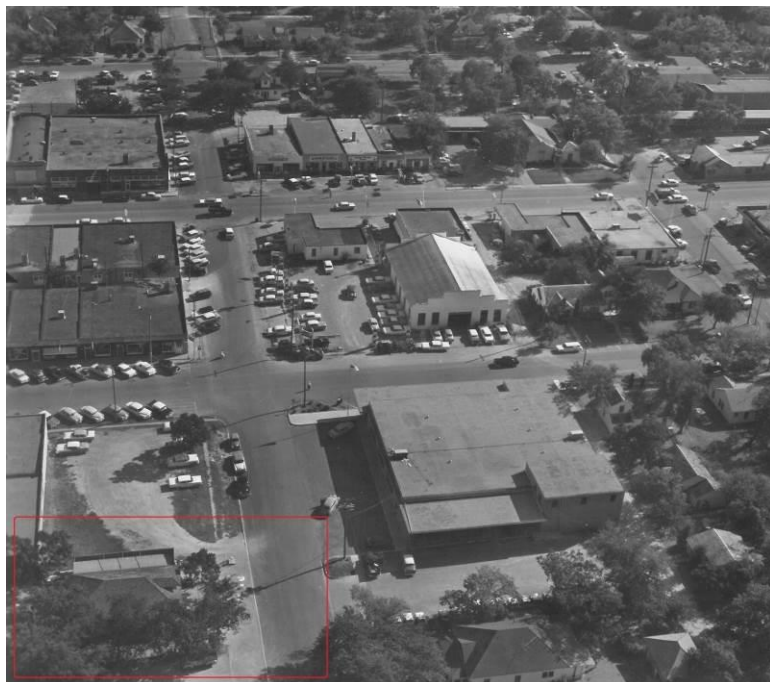
Figure 8: View looking southwest toward 212 N. 7th Street, marked in red. Note the shed constructed the length of the south elevation, c 1958. Courtesy of the Garland Landmark Society.

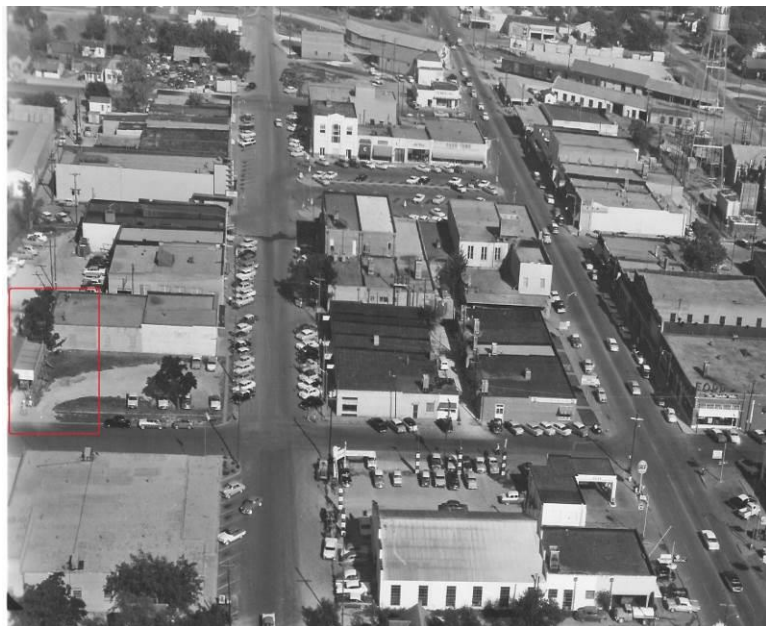
Figure 9: View looking east toward downtown, 212 N. 7th Street marked in red at the edge of photograph. Note the shed constructed on the south elevation, c 1958. Courtesy of the Garland Landmark Society.

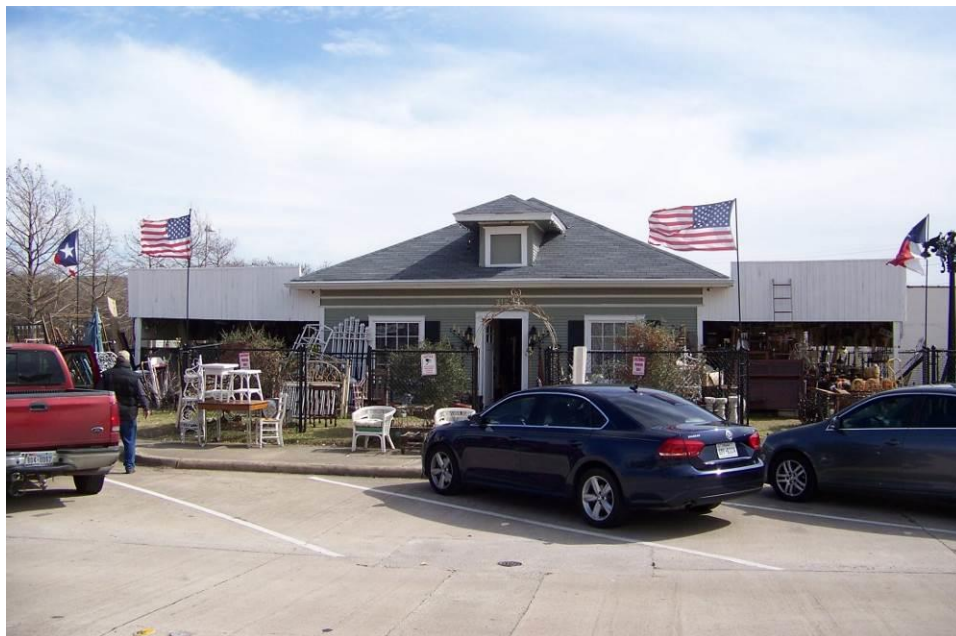
Photo 1: View east from 7th Street at front/west elevation of house. Camera facing east.

The current primary (west) elevation consists of an enclosed porch composed of a central entrance with symmetrically balanced windows on both sides, each aligned with the opening in the original façade behind it. The front porch enclosure obscures many of the stylistic details of the original house. The main portion of the house has double hung wood windows and the enclosed porch has 6/6 and 8/8 double hung windows. The house has wood stud framing, clad with wood rounded drop siding. The siding extends to the ground as a skirt concealing the foundation and crawl space. A moderately pitch hipped gray shingle roof extends the full length of the house with one central prominent dormer on the primary façade. The house has a simple one story plan. The primary (west) façade on N. 7th Street is two rooms wide and extends east roughly four rooms deep. The house also features shed additions on the north and south elevations.

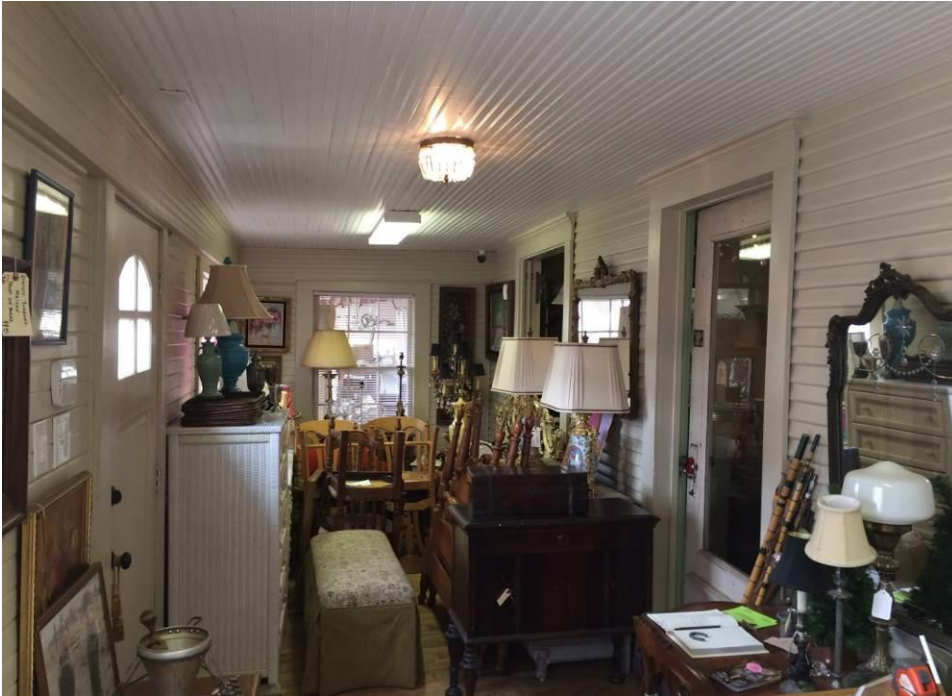
Photo 9: Interior view of enclosed front porch. Note the wood siding, front door and window trim of the original front elevation on the right side of photograph. Camera facing north.

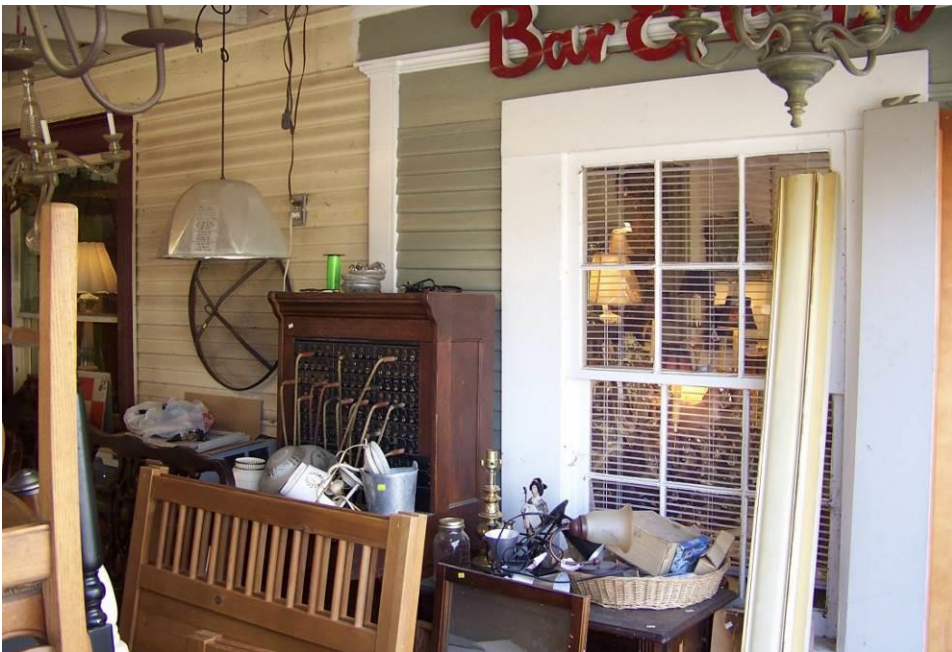
Photo 10: View of north porch enclosure wall painted green paint. The original window installed at this location at time of enclosure was used to replace deteriorated front window. This window is from a salvage yard and selected because it matched original. Camera facing southeast.

Recent repairs to the house include the replacement of deteriorated wood siding and windows, and the addition of shutters to the front façade. On the 1950s porch enclosure the wood rounded drop siding was replaced in kind from grade to the base of windows. The two deteriorated front 6/6 double hung windows were replaced with existing matching windows from the north and south walls of the porch enclosure. The windows openings in the north and

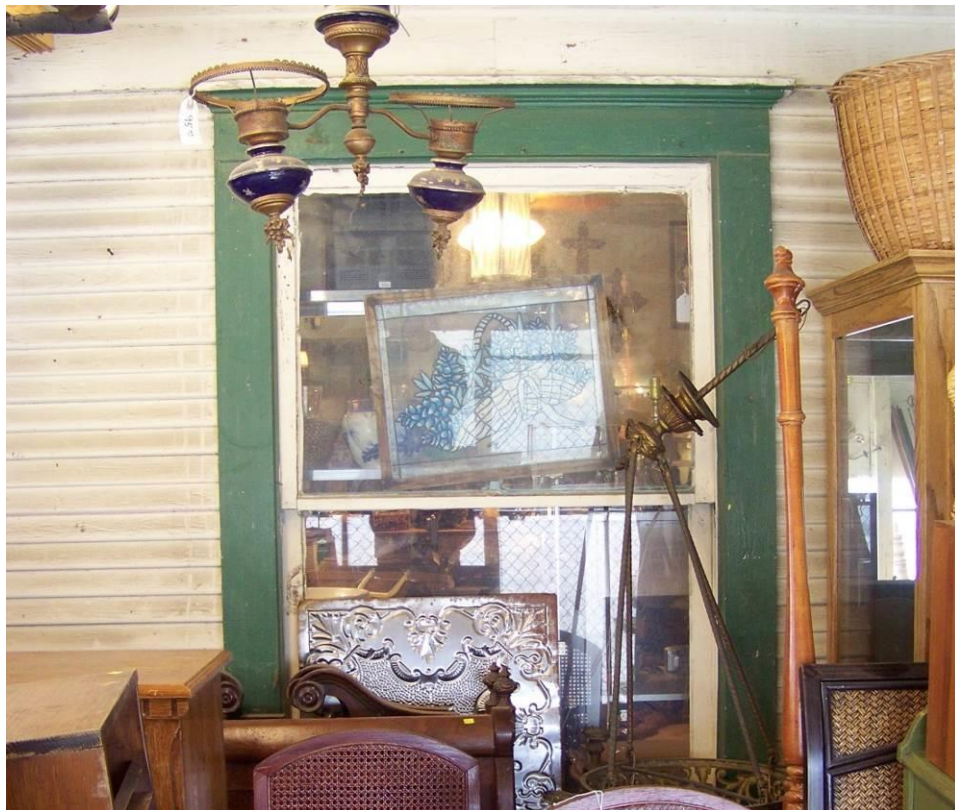
Photo 11: View of original window, trim and wood siding under the south shed. Camera facing north.

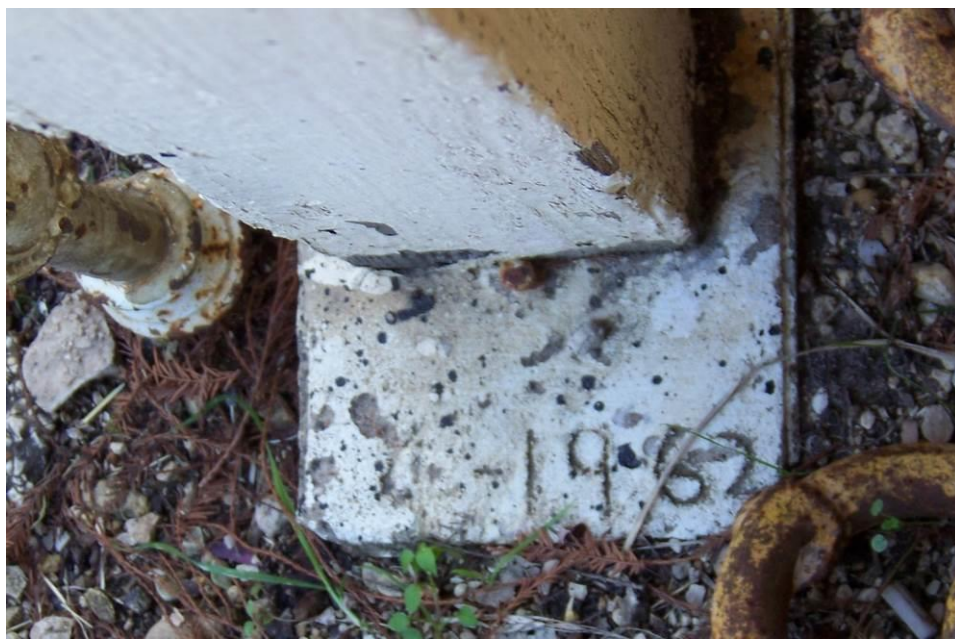
Photo 12: View inscribed concrete footing at the northeast column of shed.

In 1962 the north shed was constructed to accommodate further business expansion. The northeast column of the shed is inscribed with the construction date. In 1966, Mr. Alston diversified his commercial interests as indicated by a State of Texas Business Permit for "The Fruit Basket." This venture did not appear in Garland phone books until 1968. From 1968 to 1974 Alston's Furniture and Appliance and Alston Fruit Stand were listed at this address. By 1975, the Garland phonebook lists Alston's Fruit Stand, and not the furniture business. In 1976, Mr. Alston is listed at the 212 N. 7th address and retired. There was a period of vacancy after the death of Mr. Alston beginning in 1988 until Alston's Antiques opened in 1995.
