**DOWNTOWN GARLAND SQUARE EVALUATION:
HISTORIC PRESERVATION ANALYSIS
GARLAND, TEXAS**

Quimby McCoy Preservation Architecture, LLP
3200 Main Street #3.6
Dallas, Texas 75226

Date: December, 2012

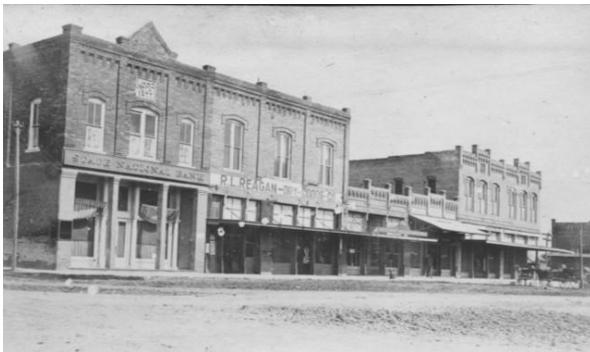
East block with three buildings that survived the fire of 1899

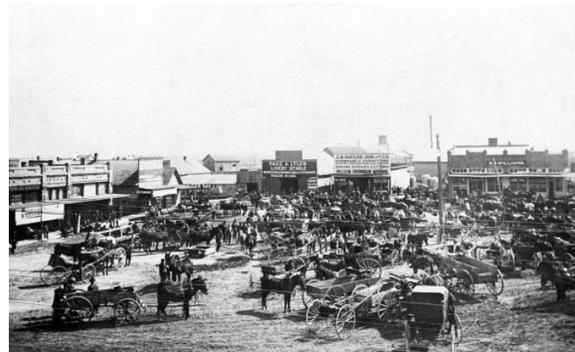
The square just six years after the fire

This fire of 1899 had a profound effect on the form of Garland's downtown. Despite the devastation, the citizens of Garland immediately began rebuilding their businesses and several buildings were added to the north and west sides of the square. Since the town center was now clear, an opportunity was seized to acquire that property and to set it aside as open space; as a result the downtown square was born. By 1901 the square was established, the remainder of the west block was constructed and the north block was nearly filled with masonry buildings one story in height. A new and improved business district thrived but fires continued to plague the downtown square including a 1902 fire which

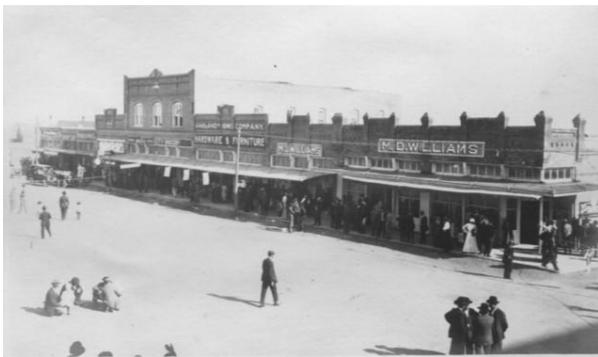
The south block in 1915 with its decorative cornices

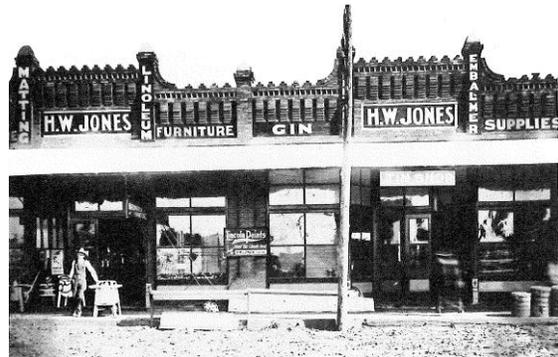
Detail of corbelled brick cornices on the north block

Many of these building were built with highly decorative corbelled brick cornices that gave the downtown an impressive and lively character. Sidewalks at this time were of wood plank and the streets were still of dirt. The square itself was dirt and was used to park horses and buggies, as well as the livestock that was traded. These animals, visitors and the businesses needed water and a trough or small well was provided near the center of the square. In 1914, a massive cistern, said to have been large enough to drive a horse-drawn carriage through, was created beneath the square.

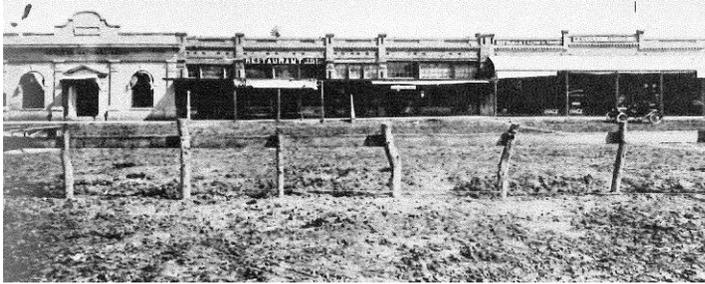
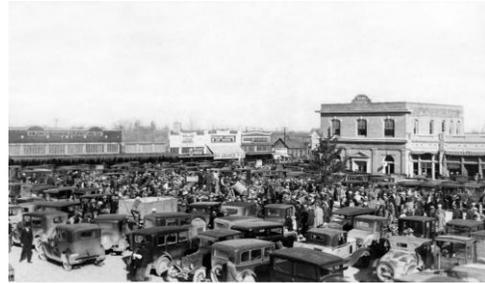
The east or “Crossman Block” c1906 (left); Jones Hardware & Furniture was remodelled in 1924 with arches, c1932 (right)

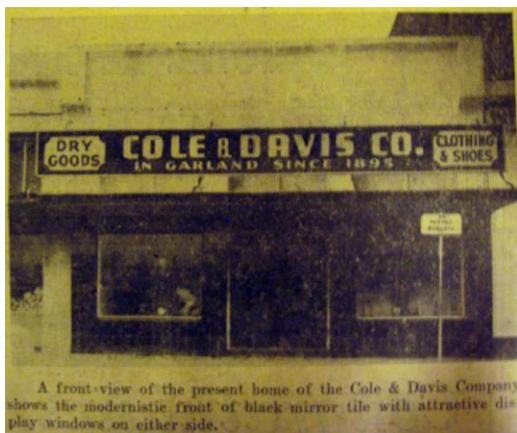
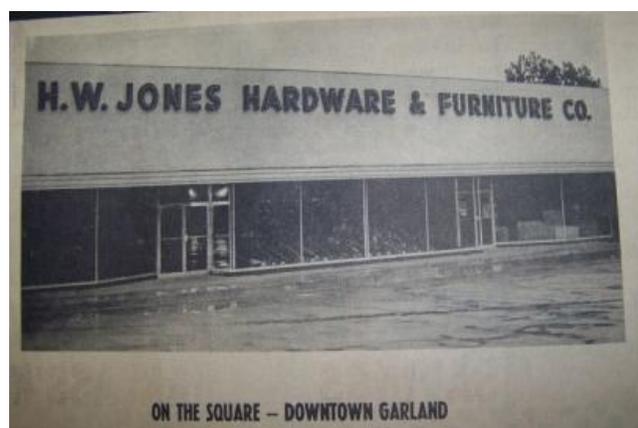
The Cole & Davis Co. store was renovated in the Moderne style (left) and the H. W. Jones Hardware & Furniture Co. was renovated for a third time in 1952 (right) to this sleek and modern appearance, much of which remains today.

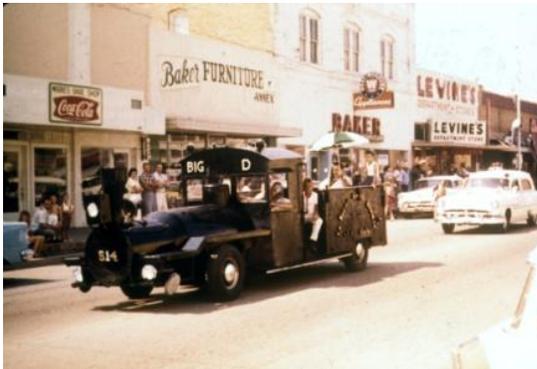
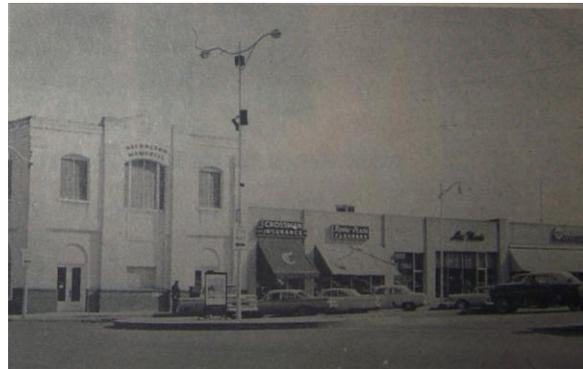
Main Street c1960 (left) and the "Crossman Block" c1962; by this time the corbelled cornices were removed, storefronts replaced, signage added and the entire block was painted in one color as a way of modernizing its appearance

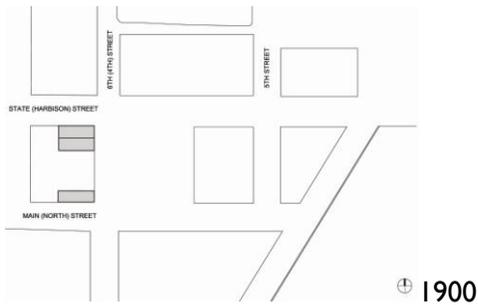
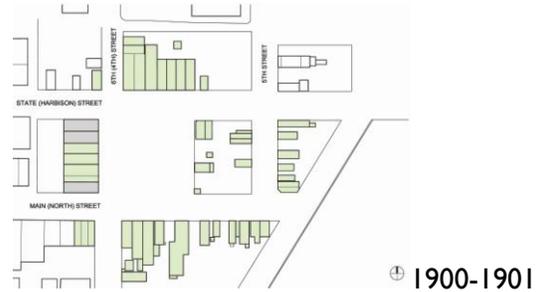
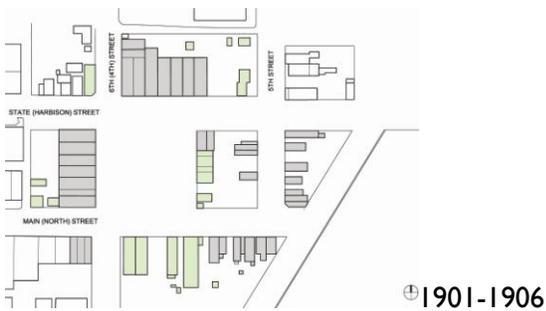
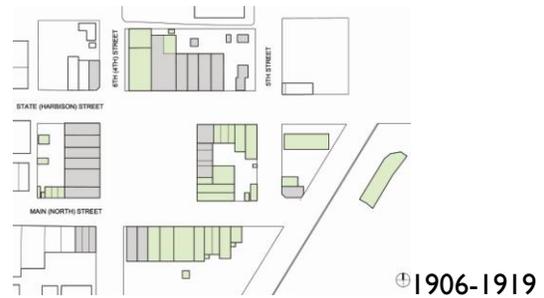
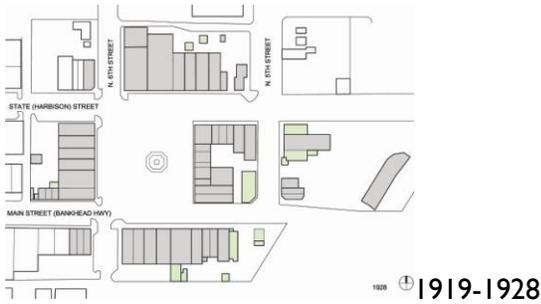
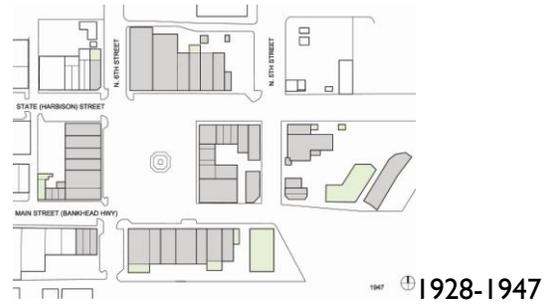
Chronology Maps

Maps depict new buildings (shown in green) by period.

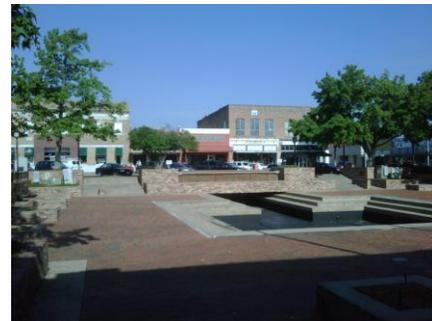
c. 1900 square; 1979 current plaza design

The space that we now refer to as the “square” took form in 1899-1900 when a group of local business people purchased the land left vacant after the fire of 1899 and donated it to the City to remain as open space or alley space in perpetuity. Initially nothing more than space and dirt, it provided a functional place for weekly trade days where it would fill with horse and buggys, livestock and farmers who would trade and then purchase necessities from the local merchants whose businesses surrounded the space. A small well or a trough was located near the center of the square for watering visitors and their animals. In 1914, the City constructed a much larger cistern beneath the square for the same purpose, described as “the big well,” it was reported to be 45 feet deep and 34 ½ feet across (The Garland News 08-28-14). By the 1920’s, the public space and the streets were used by cars and paving came by 1933. That same year, a large memorial fountain to Garland residents lost during World War I was installed, by some accounts directly over the cistern. The square continued to be used for parking around the fountain until the early 1950’s, when the fountain was removed and the parking lot was renovated. In the 1970’s, the City adopted a plan to construct a building *en piloti* (on stilts), but the building plan was dropped when city leaders found the deed restrictions requiring the square to remain as open space (Wright interview). Interestingly, the design for that building was ultimately built on South Garland Avenue instead, now home of the Chamber of Commerce). In 1976, then First Lady Rosalynn Carter attended the dedication of the current day “plaza,” designed by Oblinger & Smith of Wichita, Kansas and completed in 1979. The plaza was built-up along the sidewalk, with parking along the perimeter, and steps down to a fountain on the eastern side and trees along the edges. Upon completion, the buildings fronting the plaza were visually unified by the addition of a metal awning, some of which remains today. Although the water feature is not always in use, the plaza’s design remains unchanged.

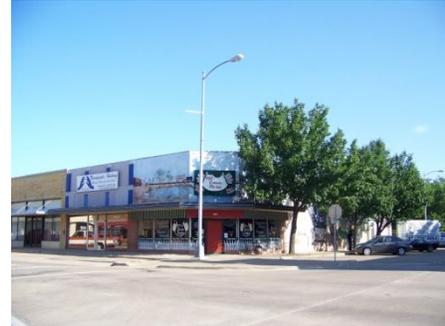
99060202480000000
 601 State Street
 c. 1906 *Contributing*

Built before 1906, this one-story brick building has a chamfered corner, the only building on the square with this feature. The building served as the first home of the National Bank of Garland. Between 1928 and 1947, the building housed the Post Office. An addition to the rear was completed before 1947. Sometime after 1947 and after the brick cornice was removed and the design simplified, the building housed other businesses including Hollenshead Appliance, which renovated in 1954 and the current restaurant (The Garland Herald, 03-01-54).

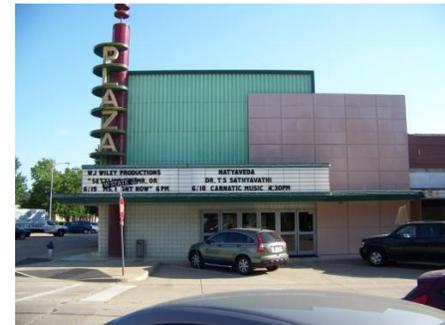
99071204280000000
 521 State Street
 Plaza Theater
 c. 1918 or 1941 *Contributing*

The earliest building on this site pre-dates 1918, but was damaged in a fire (The Garland News, 04-05-18). After the fire, a new building served as the Hudson Davis Dry Goods store, which moved to another location on the square in 1940 (The Times Reporter 09-08-57). The Plaza Theater was constructed in 1941 by H. R. and Jennie Bisby, possibly using some walls of the earlier building. An addition was completed in 1944 at the rear and in 1950 major renovations were designed by Dallas architect Jack Corgan (Granville). In 2001, the theater was restored by Garland architect Ronald Hobbs. The restoration included reconstruction of a terrazzo sidewalk.

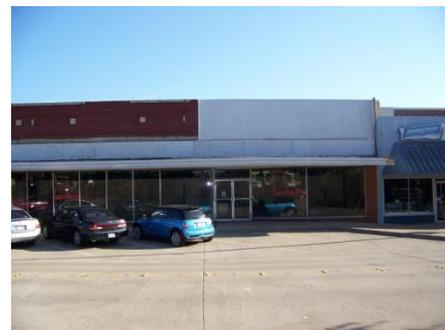
Unknown
 519 State Street
 H. W. Jones Hardware & Furniture Co.
 c. 1900 *Contributing*

Erected in 1900 for John T. Jones, E.C. Newton, and Mrs. S. Murphee, known as the Jones and Newton building, was comprised of three bays and was one of the most elaborate on the square featuring highly decorative corbelled parapets. The first two bays were occupied by the H.W. Jones Hardware, Furniture, and Undertaking business. In 1917 Jones acquired the third bay, which at that time housed the Lyric Theater, Garland's first theater. A fire in 1918 led to a significant renovation of two bays of the building, a new brick façade in a different style

featuring a simpler brick parapet with arches. In 1925, Jones finally expanded into the third, Lyric Theater, bay, which retained its original corbelled brick parapet and facade until recently. In 1952, all three bays of the building were modernized on the interior and exterior; the brick arches were removed and a metal slip-cover (or stucco – not confirmed) was used to visually connect the three bays. A new storefront and canopy completed the modern “new and improved” appearance. The name H. W. Jones Hardware & Furniture Co. decorated the entire length of the façade (Owls Nest, 1960). The 1952 slip-cover was removed from the parapet of the third, Lyric Theater bay, exposing the 1900 design. In 2010, the 1900 parapet was dismantled and covered with a temporary material, thereby removing the last original corbelled brick parapet on the square.

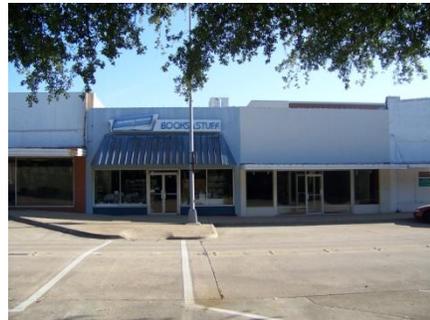
99000000121570000
 513 State Street
 c. 1900 *Contributing*

In 1901 this building housed a grocery, and in 1915 featured “C. B. Flook” on its parapet. In 1932 Garland Cash Grocery was housed here. The original façade was not as elaborate as the Jones’ but featured corbelled brick and a three-part design typical of other buildings on the square. An addition was made to the rear by 1947. The corbelled brick of the parapet was removed, the brick painted and the storefront modified sometime after 1932 and most likely in the 1950’s.

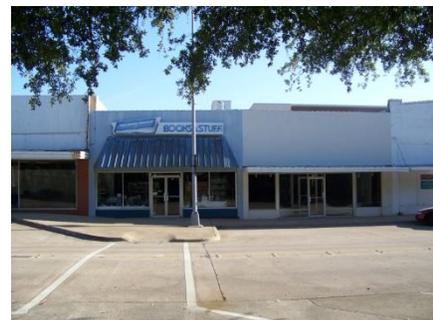
Unknown
 509 State Street
 c. 1900 *Contributing*

In 1901 this building housed the B. G. Clothing store and at other times a General Store. In 1932 it housed a Dry Goods Store. The original façade matched that of 513 State Street. An addition was made to the rear by 1958. The corbelled brick of the parapet was removed, the brick painted and the storefront modified sometime after 1932; stylistically these renovations date to the 1950’s.

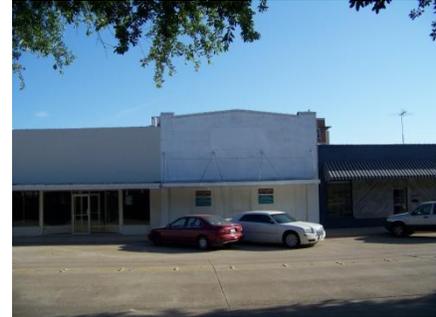
Unknown
 507 State Street
 Unknown
 c. 1918 Non-contributing

This building may have been designed to house the Harness and Tin Shop that was housed there in 1919, since the floor is shown to be concrete. In 1932 plumbing supplies were sold there. The building retains its original parapet, one of the few on the square to do so, but it cannot be considered a building because the roof is missing and the walls are deteriorating due to their prolonged exposure; it is assumed that a reconstruction would be required to reuse this building, which would leave it without sufficient historic integrity. Because the structure is missing its roof, it cannot function as a building and is therefore designated as non-contributing.

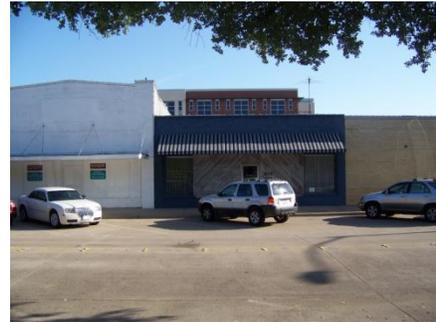
Unknown
 505 State Street
 Unknown
 c. 1958 *Contributing*

This portion of the block once contained the Garland Hotel, a two-story wood structure that was lost to fire in 1932, and remained open for many years (Garland News, -6-17-32). Sometime between 1947 and 1958, this simple brick building was constructed with a flat parapet, devoid of decorative elements, since painted. The storefront was most likely remodeled in the 1970's.

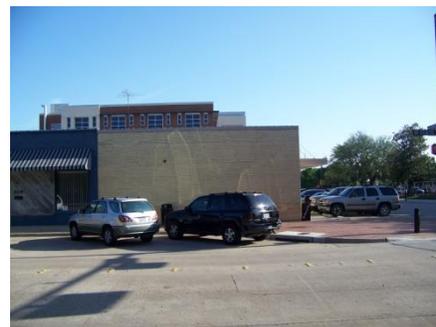
Unknown
 203A North 5th Street
 Unknown
 c. 1953 *Contributing*

Built by the City of Garland as a police station and jail, this building consists of a blank buff brick wall with a flat parapet facing the square. The City allocated funding for this building in 1953 (Garland Herald, 06-10-52). Funds were appropriated the same year for the acquisition of land for a new City Hall across State Street. The primary façade faces 5th Street. The police relocated to a new Police & Courts building on 5th Street in the 1960's. An addition was made to the rear and facing 5th Street sometime after 1958 and the 5th Street façade has since been improved.

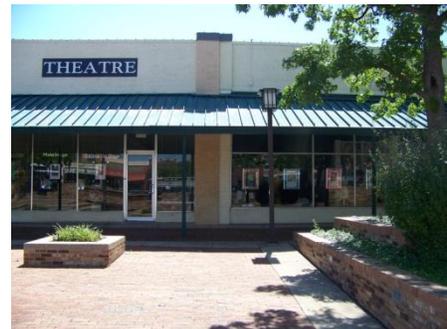
26165500020020000
 102-108 N. 6th Street
 Crossman Block
 1906; 1907-12 *Contributing*

This group of brick buildings became generally known as the “Crossman Block” for the Crossman family, who owned Garland’s first insurance agency and operated out of this location until the 1980’s (Garland News Supplement – 09-29-86; Hayslip). Adjacent to the Alamo-style bank on the corner were four storefronts designed as one building and built in 1906. Initially these storefronts housed a restaurant, tailor, barber and a Post Office. On the end of the block near Main Street, another three- storefront building was built between 1907 – 1912, which served as a drugstore with a restaurant and a variety store. The two stages of building retained the same design, providing a unified appearance to the block. Each storefront was articulated at the parapet and a simple corbelled brick design provided relief. The 1920’s brought changes to the occupancy of the block but the buildings remained the same. The Atlantic & Pacific grocery (A&P) moved into the three storefronts at the corner of Main in 1926, where it remained through 1955, possibly later. Sometime before 1951, Crossman Insurance had renovated its storefront in a 1930’s Moderne design and the entire row may have been renovated. By 1958, the buildings had lost their corbelled brick parapets and were painted to create a unified and simplified design to the entire block (GLS photo of Lea

Nans (ladies clothing); 1958 aerial). In 1979 a metal canopy was installed on all the buildings fronting the square, and it remains here, along with the pre-1962 renovation. The multiple-tenant storefronts that changed many times during the past one hundred years are now a single tenant – the Garland Civic Theatre, which uses the building for storage, administrative offices and rehearsal space.

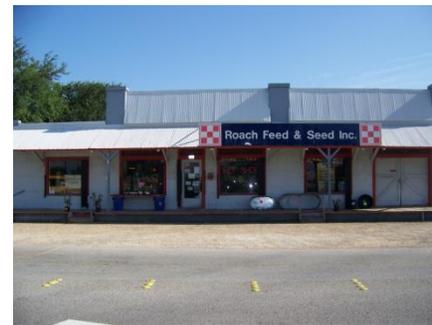
99000000135415000/
26165500010000000
409 Main Street
Roach Feed & Grocer Company
1933 *Contributing*

The business was established in 1933 after Roach sold his grocery business located at the south-east corner of Main and 6th Streets. The new business was housed in new buildings and in a renovated “Onion Shed” that existed on the site by 1919 and was purchased from the railroad. Clad in metal panels simulating brick, this frame building is one of the last wood structures on or near the square. Few changes have been made, including minor modifications to signage at the parapet, an extension of the canopy and a raised platform built in c. 1954 to encompass the west wing. A Quonset hut, initially built for WWII surplus by the Army, was added prior to 1958. Later, a greenhouse, recently enclosed, was added to the rear of the building. The Roach’s business has operated out of this building since the summer of 1933. Roach was in partnership with Earl McDaniel Sr. in the Roach & McDaniel Grain Company through 1952 and located further north on 4th Street. Earl McDaniel’s son, Earl (Jack) McDaniel Jr. joined the business in 1949 and eventually bought out Roach (Earl (Jack) McDaniel Sr., 07-21-11). McDaniel still runs the business today. In 1955 Roach’s son Richard founded an insurance agency in the west end of the store that evolved into the Roach, Howard, Smith & Barton Agency with offices in Dallas and Fort Worth. The parking lot to the west of the buildings was built by the City.

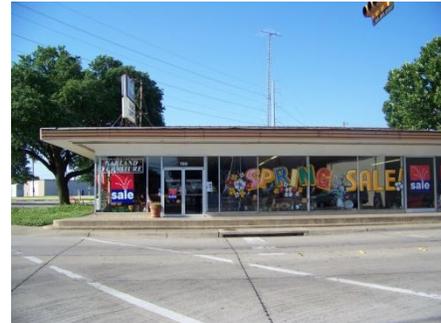
26165500090010000/
 99972050000187950
 500 Main Street
 Wood Pruitt Building
 1946 *Contributing*

This building, now occupied by Garland Furniture, was built in 1946 by Joe T. Wood, a local auto dealer and was probably intended for auto sales, but was used to sell appliances instead until auto sales resumed after WWII. Wood Pruitt Motor Company moved out of this building in 1953, after which it was used as the Garland Furniture Store (The Garland Herald, 01-08-53). The sleek design of this building consists of a deep canopy over an all-glass storefront that wraps around the corner. The only known significant modification to this building may have occurred in the rear when 5th Street was extended.

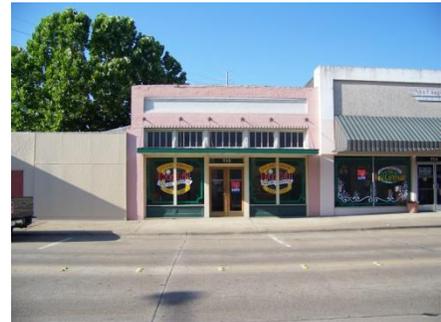
26165500090020100
 510 Main Street
 c. 1911 (1906-1915) *Contributing*

Built by 1915 as a meat store and used later an electric motor shop with a concrete floor and “steel ceiling,” this brick building appears to retain its original façade, one of a handful to do so on the square. In the early 1960’s, Jones Bicycle & Lawnmower Shop moved into the building and by then the storefront had been changed and the brick painted. The current storefront may be a restoration, although the transom windows could be original. The brick façade is most likely as it was built in 1915, but painted.

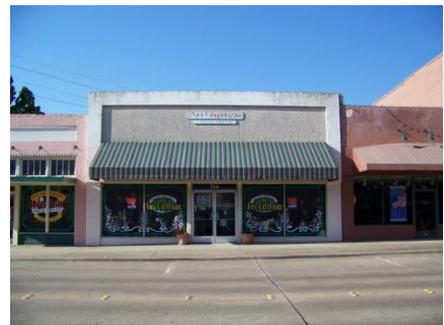
26165500090020000
 514 Main Street
 Texan Theater
 c. 1911 (1906-1915) *Non-contributing*

This two-storefront wide brick building was erected around 1911 and early on housed Souter’s Café and Hoffard’s Bakery. It was designed similarly to 510 Main with a simple brick parapet, transom windows, and a canopy over the storefront. In 1947 the building was purchased by Mr. and Mrs. H. R. Bisby, who also owned the Plaza Theater and the Garland Theater (Granville). An addition was made to the rear of the building, most likely in 1947 but before 1958. It is not known when the Texan ceased to exist but the façade was completely renovated by the early 1960’s when Moore’s Shoe Shop was housed there (GLS color photo with Big D truck). The façade was altered again by 1978 by which time it had taken on the current appearance.

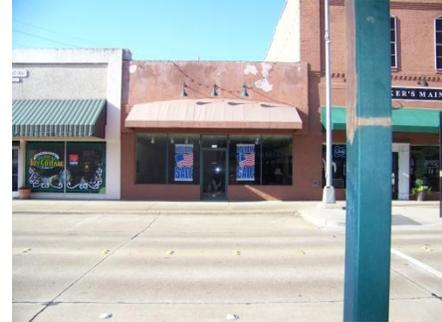
26165500090030100
 520 Main Street
 Garland News
 1911 *Contributing*

This brick masonry building was constructed in 1911 and was first occupied by the Garland News until 1936 (Hayslip). It originally had a much taller and more elaborate parapet with a strong central brick element featuring a flat arch and the word “news” (GLS photo, 1915). The design of the façade was the same as that of 528 and 524 Main, indicating that they were built at the same time. In the late nineteen-teens it became a drug store and a jewelry store; in fact, the building experienced a frequent turnover of occupancy until the 1950’s, when it became a furniture store (Flook). By the early 1960’s the taller and more elaborate parapet was removed, a modern canopy was added and the storefront changed and it became Baker Furniture Annex. It is unclear when the current stucco facade was installed –the late 1950’s or early 1960’s.

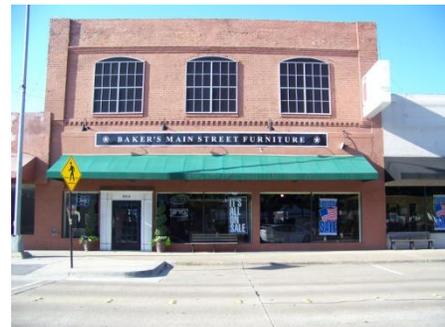
26165500090030000/
 99091215110000000/
 99110516500000000
 524 Main Street
 1911 *Contributing*

Originally erected in 1911 by T.N. Hickman, the first floor was occupied by City Grocery and a drug store and the upper floor was used as an opera hall and auditorium. The brick façade featured a decorative parapet with a central element of a design similar to that of the two flanking buildings beside it (GLS photo, 1915). The 1919 Sanborn map shows furniture and hardware in this location. In 1932 Baker Hardware moved into the building. In 1950 the front of the building was remodeled and an addition was made to the rear. In 1953, Baker altered the building by raising the second floor to make room for another floor above the first floor, essentially making it a 3-story building on the inside (The Garland Herald, 07-30-53). The brick was painted and the original paired wood windows were replaced or covered by sunscreens by the early 1960’s, most likely in 1950 when the façade was renovated.

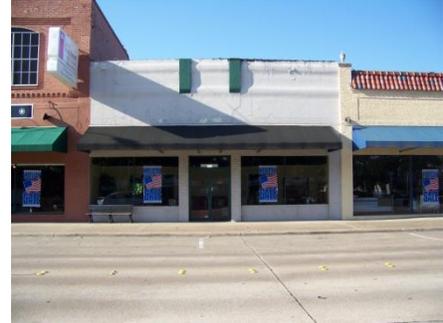
26165500090040000
 528 Main Street
 1911 *Contributing*

This building was built and designed with 520 and 524 Main with the same brick parapet design, transom, canopy and similar storefronts. Built for the firm of J. M. Naylor and Son, the building, known as the “Naylor Building,” was purchased by L. A. Powell of the Powell-Allen Company in 1920 (Garland News, 01-23-20). Photographs show that it was occupied by the Garland Hardware Company in 1915 (GLS photo, 1915). Other occupants include Powell’s, Hunts, and Levine’s Department Store by the early 1960’s (GSL photo). It is not known when the decorative parapet was removed nor when the stucco was added to the façade.

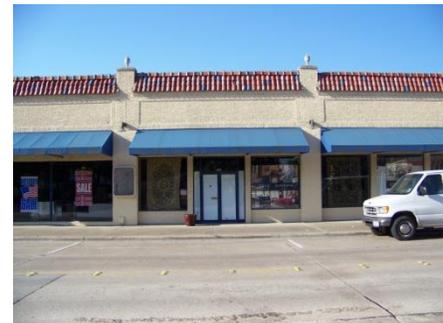
26165500090050000
 532 Main Street
 Unknown
 1906 *Contributing*

Originally known as the M. D. Williams building; a grocery, warehouse, and undertaker once occupied this three-storefront wide building. The brick façade featured a decorative parapet similar to that of other buildings on the square at the time. M. D. Williams started in two storefronts, but moved into the third when it was built in 1911. A fire in broke out in the company’s first building in 1902, caused by the explosion of a lamp in Mr. Williams’ hand (Corcocran, Nov. 1989), which caused the destruction of four storefronts along Main Street. A smaller brick building was built to replace these in 1906. In 1920, the Roach Grocery Company business operated out of this building (McDaniel, 07-21-11). In 1931 the façade was modernized in the Spanish Colonial style which was popular at the time and can be found on the Garland High School and on the former Williams Funeral Directors place of business further west on Main Street. Roach sold that grocery business and moved down the street to establish Roach Feed & Grocer Co., a distributing wholesale grocery business and retail business. A 1949 Owls Nest Yearbook photo shows Safeway in this building and subsequent to that time it was occupied by Worthington’s. The building retains its 1931 façade characteristics and is currently occupied by Baker Furniture.

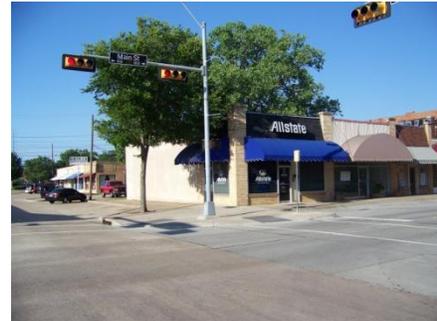
26165500080010100/
 99071203390000000
 600 Main Street
 Allstate Insurance
 c. 1901 *Contributing*

This brick building consists of three bays that originally featured a brick parapet design with extended pilasters. The parapet was redesigned, most likely in the 1950's; the façade of the building was remodeled using a brick similar to that on the 101 North 6th Street building. A café and barber shop were located in the building in 1938 and a dry goods store operated in the building into the 1950's.

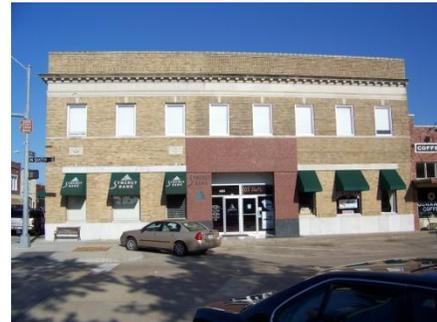
26165500030030000
 101 North 6th Street
 Knights of Pythius (portion of building)
 1897 - c1954; c1901 – c1954 *Contributing*

Constructed in 1897 by the Knights of Pythias, a portion of this building is one of only three buildings that survived the 1899 fire, no doubt due to its masonry construction. The original 1897 building featured a central pediment and corbelled cornice and a cast iron storefront. In 1911 the First Guaranty State Bank occupied the first floor and in 1913 merged with National Bank of Garland to form State National Bank. The building next door was constructed by 1901 in a similar design but without the central pediment. It was occupied by R. L. Reagan Dry Goods Company in 1915. Three smaller storefronts within one building, located at 603-605 Main, were constructed by 1919 and would later be engulfed into the bank's 1954 expansion. Plans were drawn up by Dallas architects Flint & Broad for the remodeling of the 1897 building in the Neo-classical style and incorporating both floors of the building at a cost of \$30,000 (rendering, Garland News, 02-22-24). The newspaper description of the plans refer to this as a "re-building," a "remodeling," and as a "new building," leaving the author at a loss for understanding how much, if any, of the 1897 structure remains, but it has been assumed for this report that at least most of the structure, floors and roof framing dates to that earlier period. The adjacent 1897 building retained its original appearance as late as 1926 (Garland News, 05-25-26). In 1946, Western Auto Associates was located there and announced an expansion at the rear and remodeling work (Garland News 11-29-46). In 1954, the two buildings were combined as part of an extensive renovation and expansion of the State National Bank.

The façade was re-designed, un-matched floor levels between the two buildings were connected, windows changed and a central entrance was created on 6th Street. A drive-through banking window was installed at the rear of the building as part of a large one-story addition. 603-605 Main Street was renovated at the same time; the brick on its façade matches that of the 1954 façade. More recently, the Synergy Bank has occupied the building with one tenant on the ground floor.

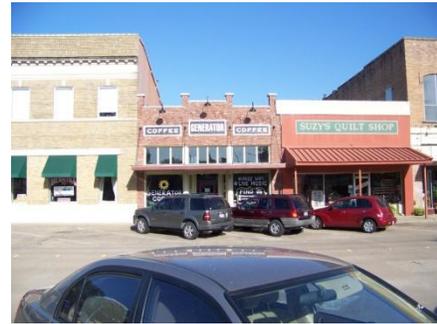
26165500030020000/
 26165500080100100/
 99090923350000000/
 99200334600034400
 107 North 6th Street
 2010 *Non-contributing*

Originally built in 1901, the brick façade featured a corbelled brick parapet and taller than usual extended pilasters to match those of its immediate neighbor and the Odd Fellows Building, one of the more ornate treatments on the square. Transom windows, a canopy and what was most likely a cast iron storefront completed the original design. The façade was renovated before the 1950's, at which time the decorative brick was removed from the parapet. In 1979 the building was occupied by Accent Lighting Mirrors & Glass Co. and what was left of the façade was covered by signage. The current owner reconstructed the 1901 design in 2010.

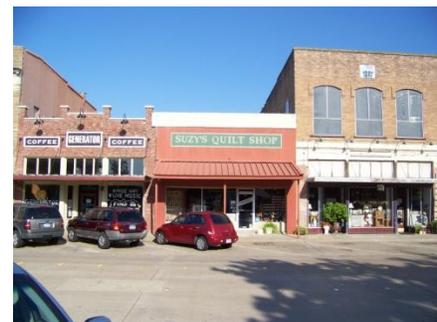
26165500030020100/
 99903060000006950/
 99071205330000000
 111 North 6th Street
 1901 *Contributing*

This brick building looked identical to its neighbor at 107 North 6th Street when originally built. It was occupied in its early years by a drug store but was better known as the site of Cole & Davis Co, an established clothing and dry goods store that moved to this location in 1940 (Times-Reporter, 1957). The company's façade featured a Moderne style storefront with black tile and glass, a streamlined canopy and matching sign (Owls Nest Yearbook, 1949). The sign is now mounted to the party wall of the building and can be seen from the back alley. In 1951 the interior was modernized and a mezzanine, partial basement and an addition to the rear were added (The Garland Herald, 08-30-51). Cole & Davis remained in this location at least until 1979 (GLS photo, 1979).

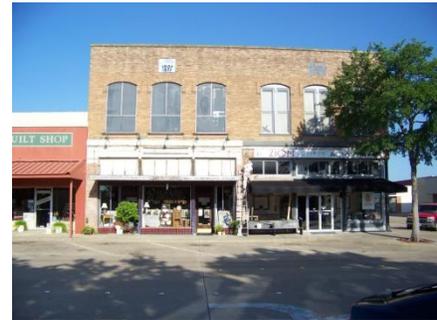
26165500030010000/
 99200334600035950/
 99952140000142750
 113 North 6th Street
 Odd Fellows Building
 1897

The Odd Fellows Building is one of the three remaining survivors of the 1899 fire. The handsome two-story building was built for the fraternal organization and provided lodge meeting space on the second floor and a cast iron storefront on the ground floor with transom windows and a canopy. The parapet featured corbelled brick and extended pilasters very much like, if not exactly like, that of the two buildings on the block to its south. In 1923 Nicholson Variety Store opened and operated out of the building through at least 1979. An addition was made to the rear between 1947 and 1958. This building retained its original cast iron front. This building and its matching neighbor, the Mason’s Building, were built at the same time, in the same design and have retained their historic integrity better than most of the buildings on the square, despite the loss of their corbelled parapets.

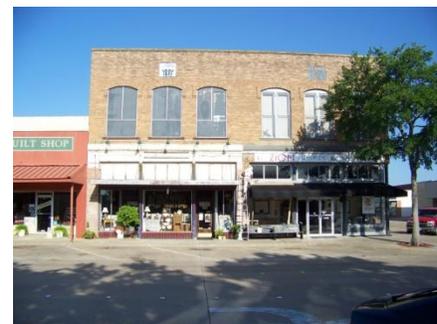
26165500030010100/
 99090923390000000
 115 N. 6th Street
 Mason’s Building
 c. 1899

The Mason’s Building, another survivor of the 1899 fire, is a near replica of the Odd Fellows Building next store, except that it has a façade on State Street. The handsome two-story building was built as a Masonic Lodge with meeting space on the 2nd floor and a cast iron storefront on the ground floor with transom windows and a canopy. An addition was made to the rear between 1947 and 1958 that housed storefronts on State Street. McKnight Drug, a local hangout since 1897, occupied the ground floor at least until 1985 (Garland Daily News, 09-29-85). Today, the ground floor houses the Zion Church Spirit & Truth. The windows and storefront have been replaced but like its neighbor, this building retains a great degree of historic integrity, despite the loss of its corbelled parapet.

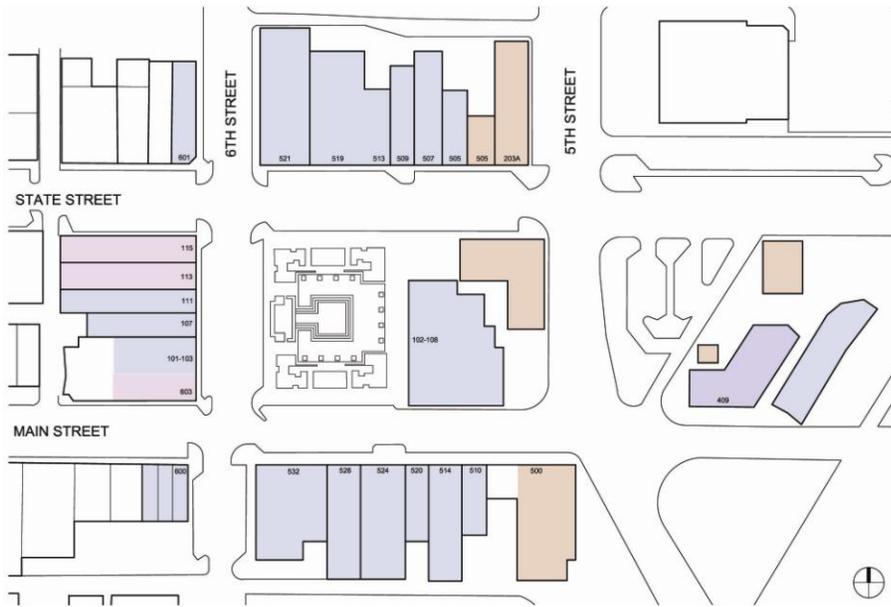
The period of construction for the majority of the buildings on the square is 1900-1920 (blue). Three buildings were constructed before 1900 and survived the fire of 1899 (purple) and four buildings were constructed between 1940 and 1960 (pink).

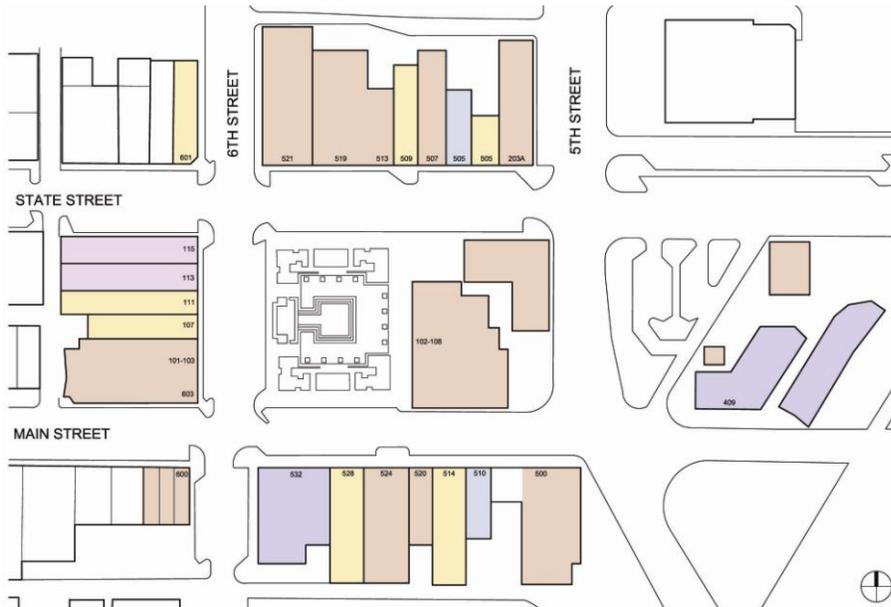
The period of alterations and additions to the buildings on the square varies, but the predominant date of the current improvements on these buildings is between 1940 and 1960 (pink). The square and the buildings that define it no longer reflect their original design, yet they do reflect the changes that Garland has undergone over the past 110 years of its history.
